**EGLIN AIR FORCE BASE
Florida**

RANGE ROADS

**FINAL PROGRAMMATIC
ENVIRONMENTAL ASSESSMENT**

DECEMBER 2002

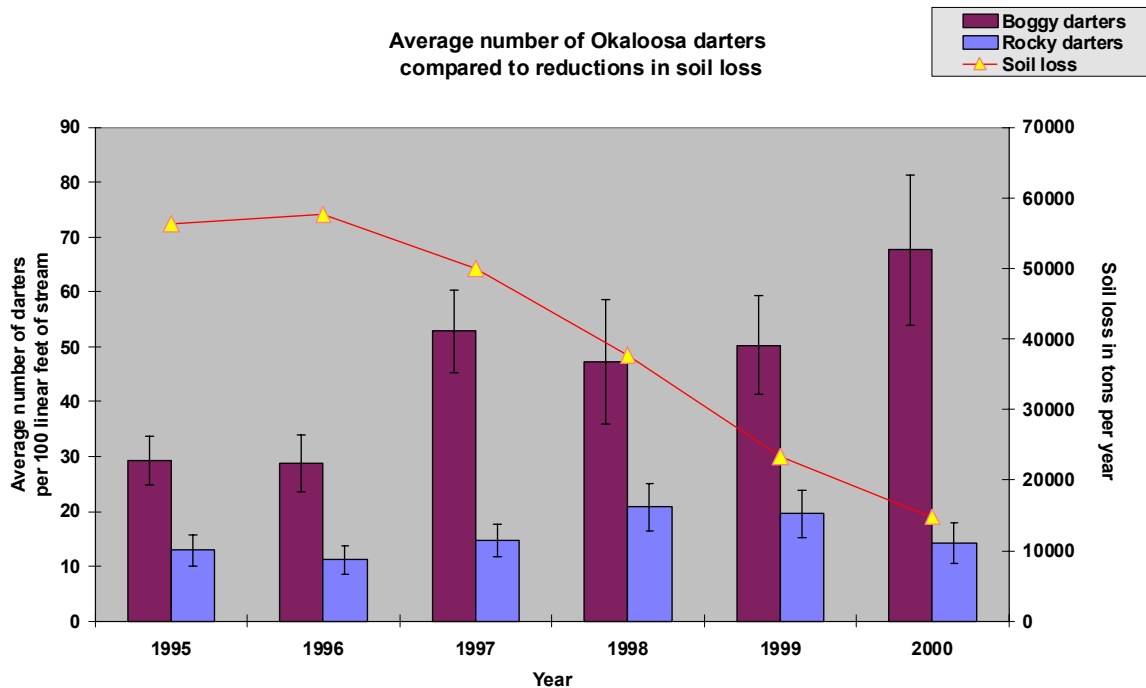
Figure 4-1. Estimated Correlation Between Reduced Soil Loss and Darter Populations

Although fewer than 10,000 Okaloosa darters are thought to exist, the current population levels have been assessed as stable. However, stability of desired aquatic habitat components is dynamic at best and susceptible to alteration in form and function by improper natural resource maintenance/management practices (U.S. Fish and Wildlife Service, 1998). Habitat conservation measures such as implementation of road erosion reduction practices, and closure of nonessential roads have improved darter habitat by reducing stream sediment loading. Figure 4-1 clearly demonstrates the correlation between reduced soil loss and darter populations.

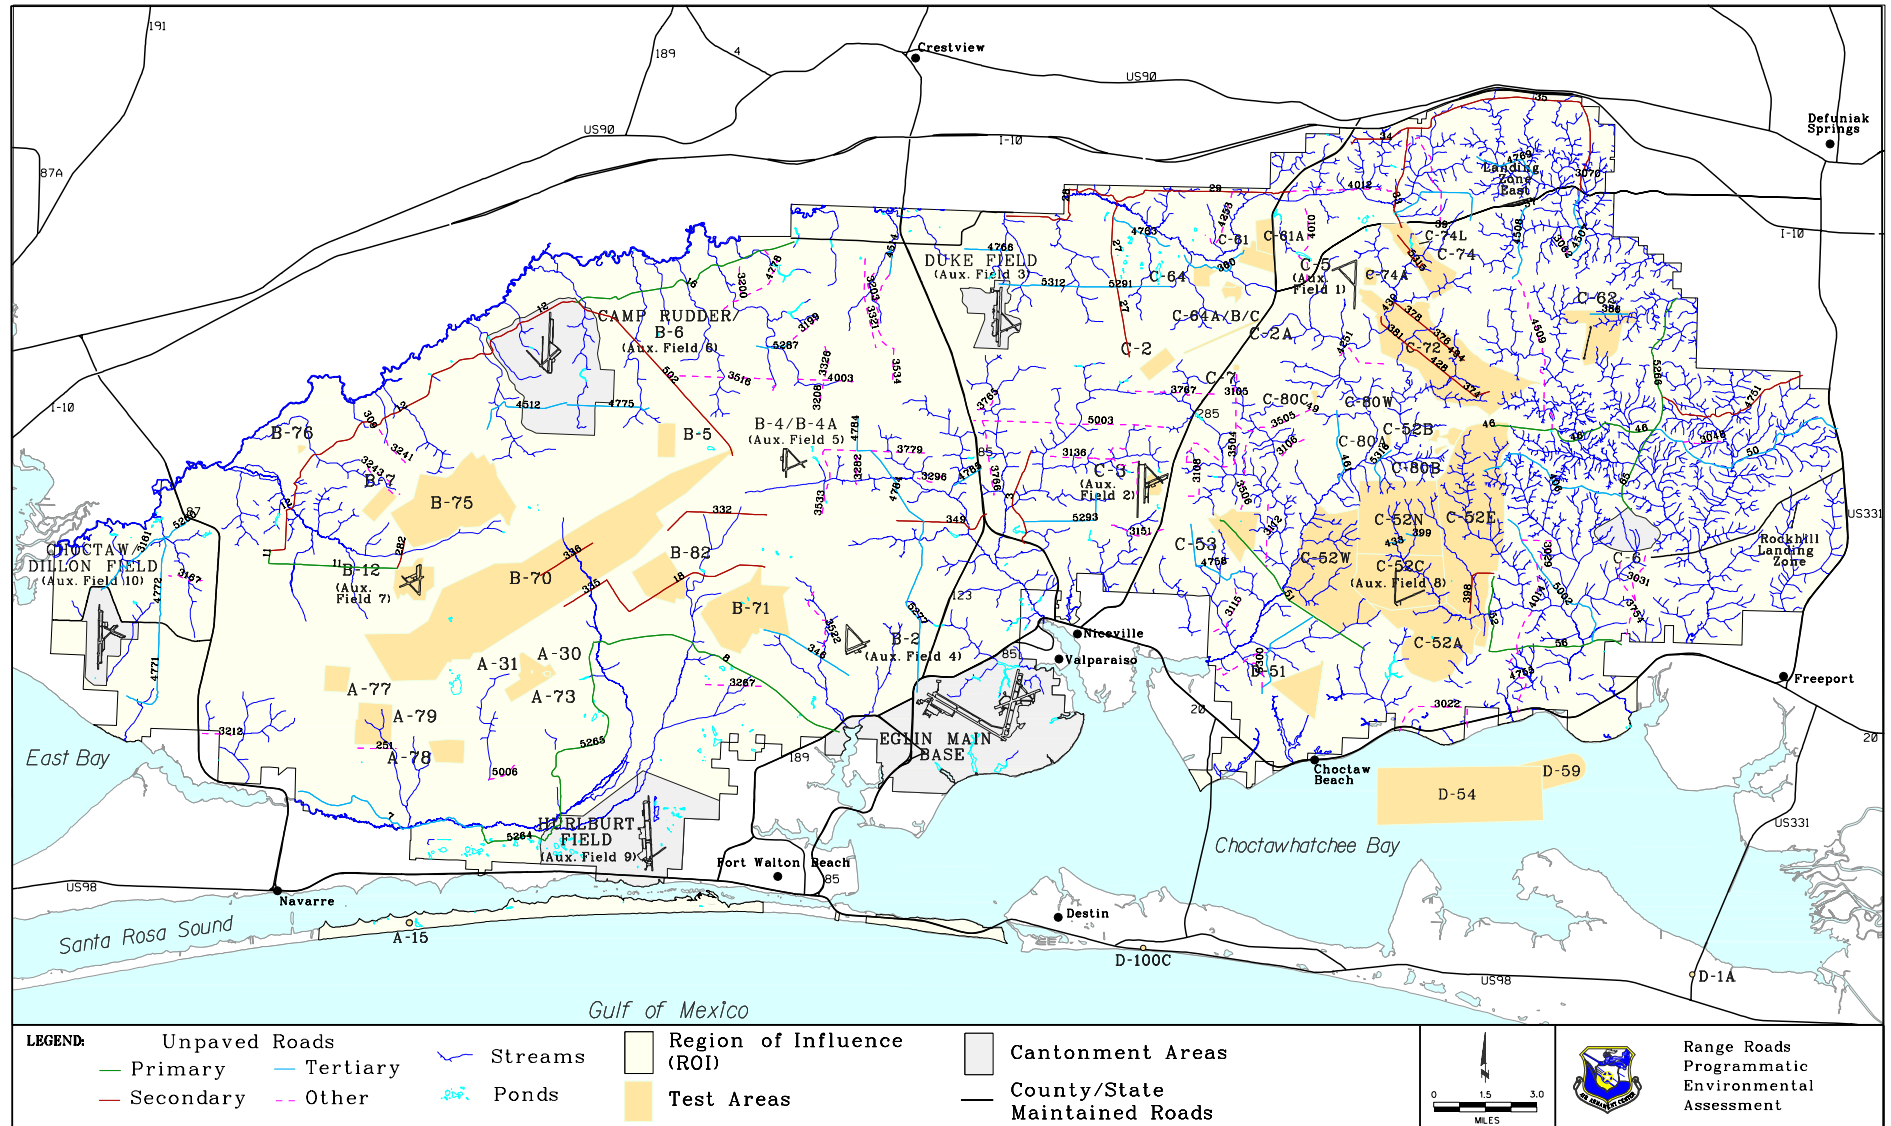
Figure A-1. Stream Crossing by Unpaved Road Segments

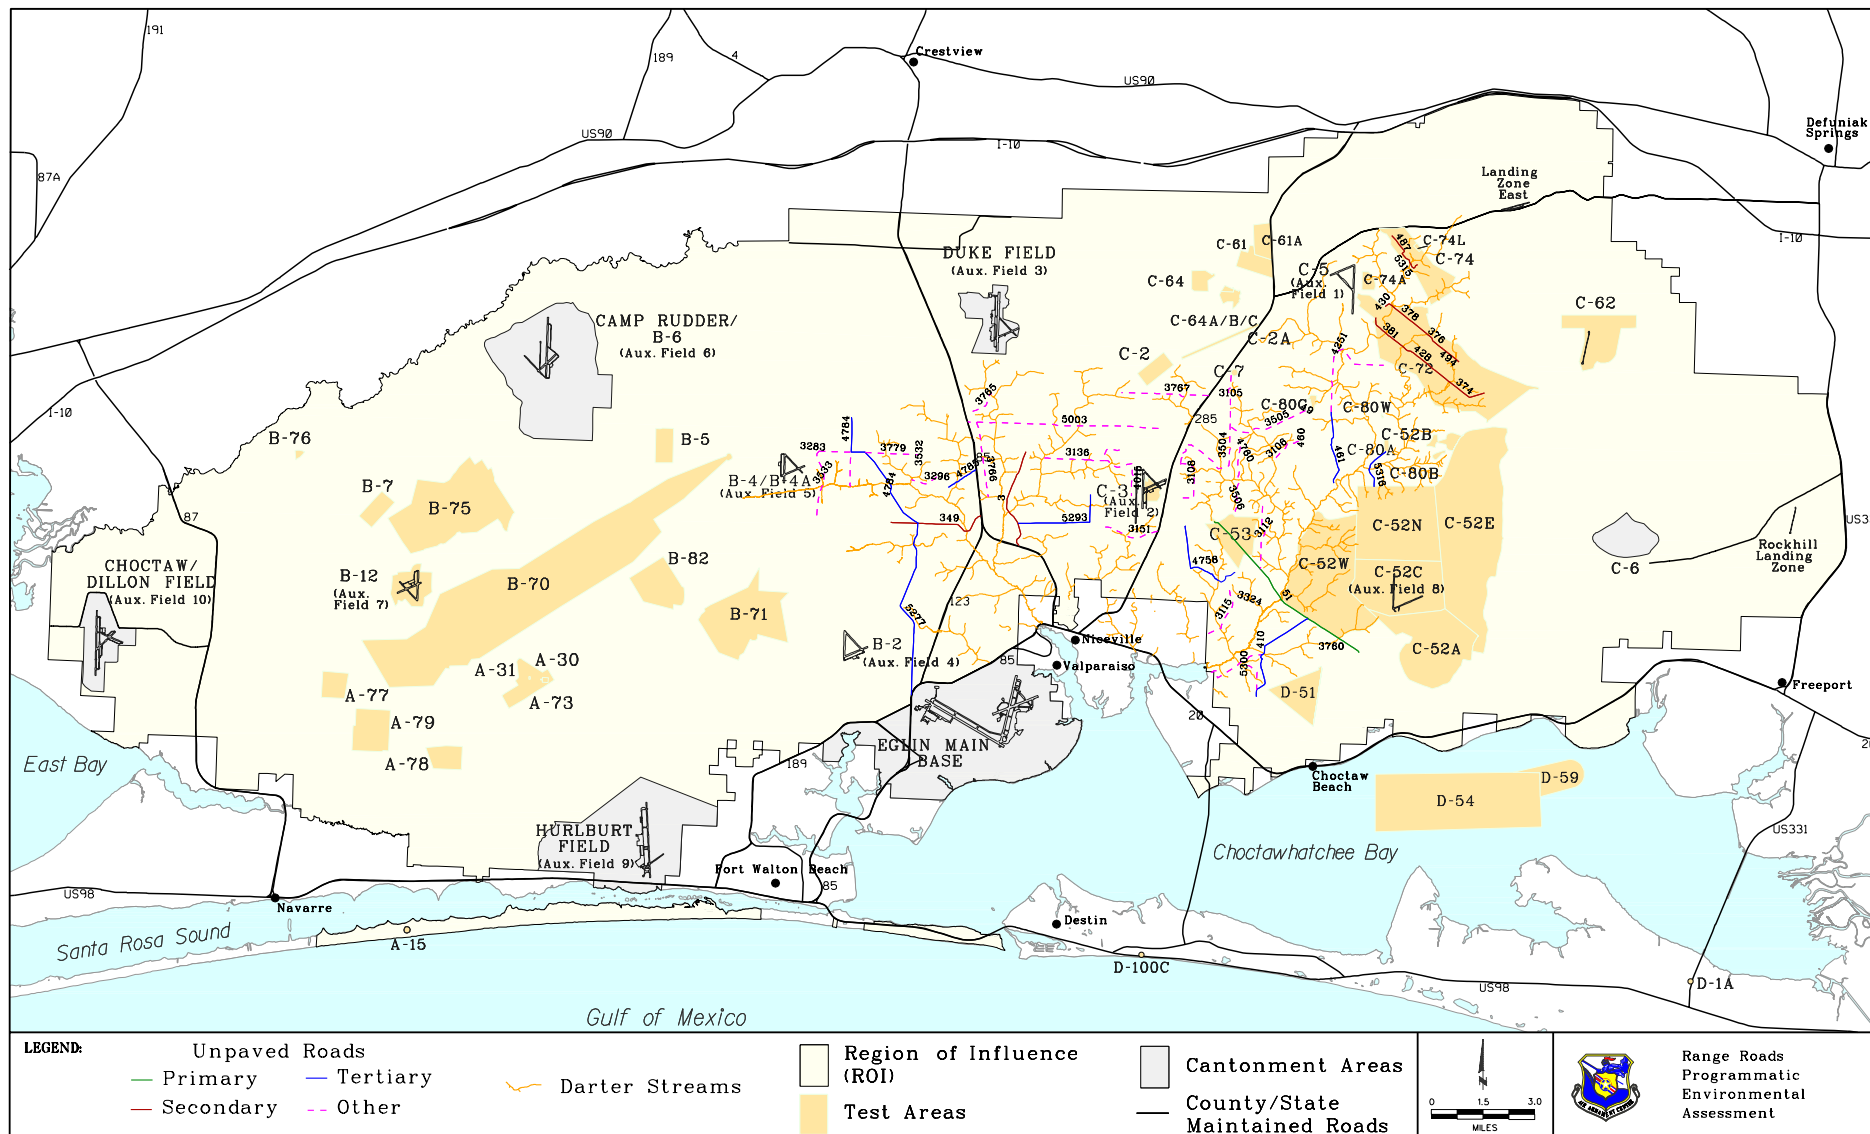
Figure A-2. Unpaved Road Segments Crossing Darter Streams

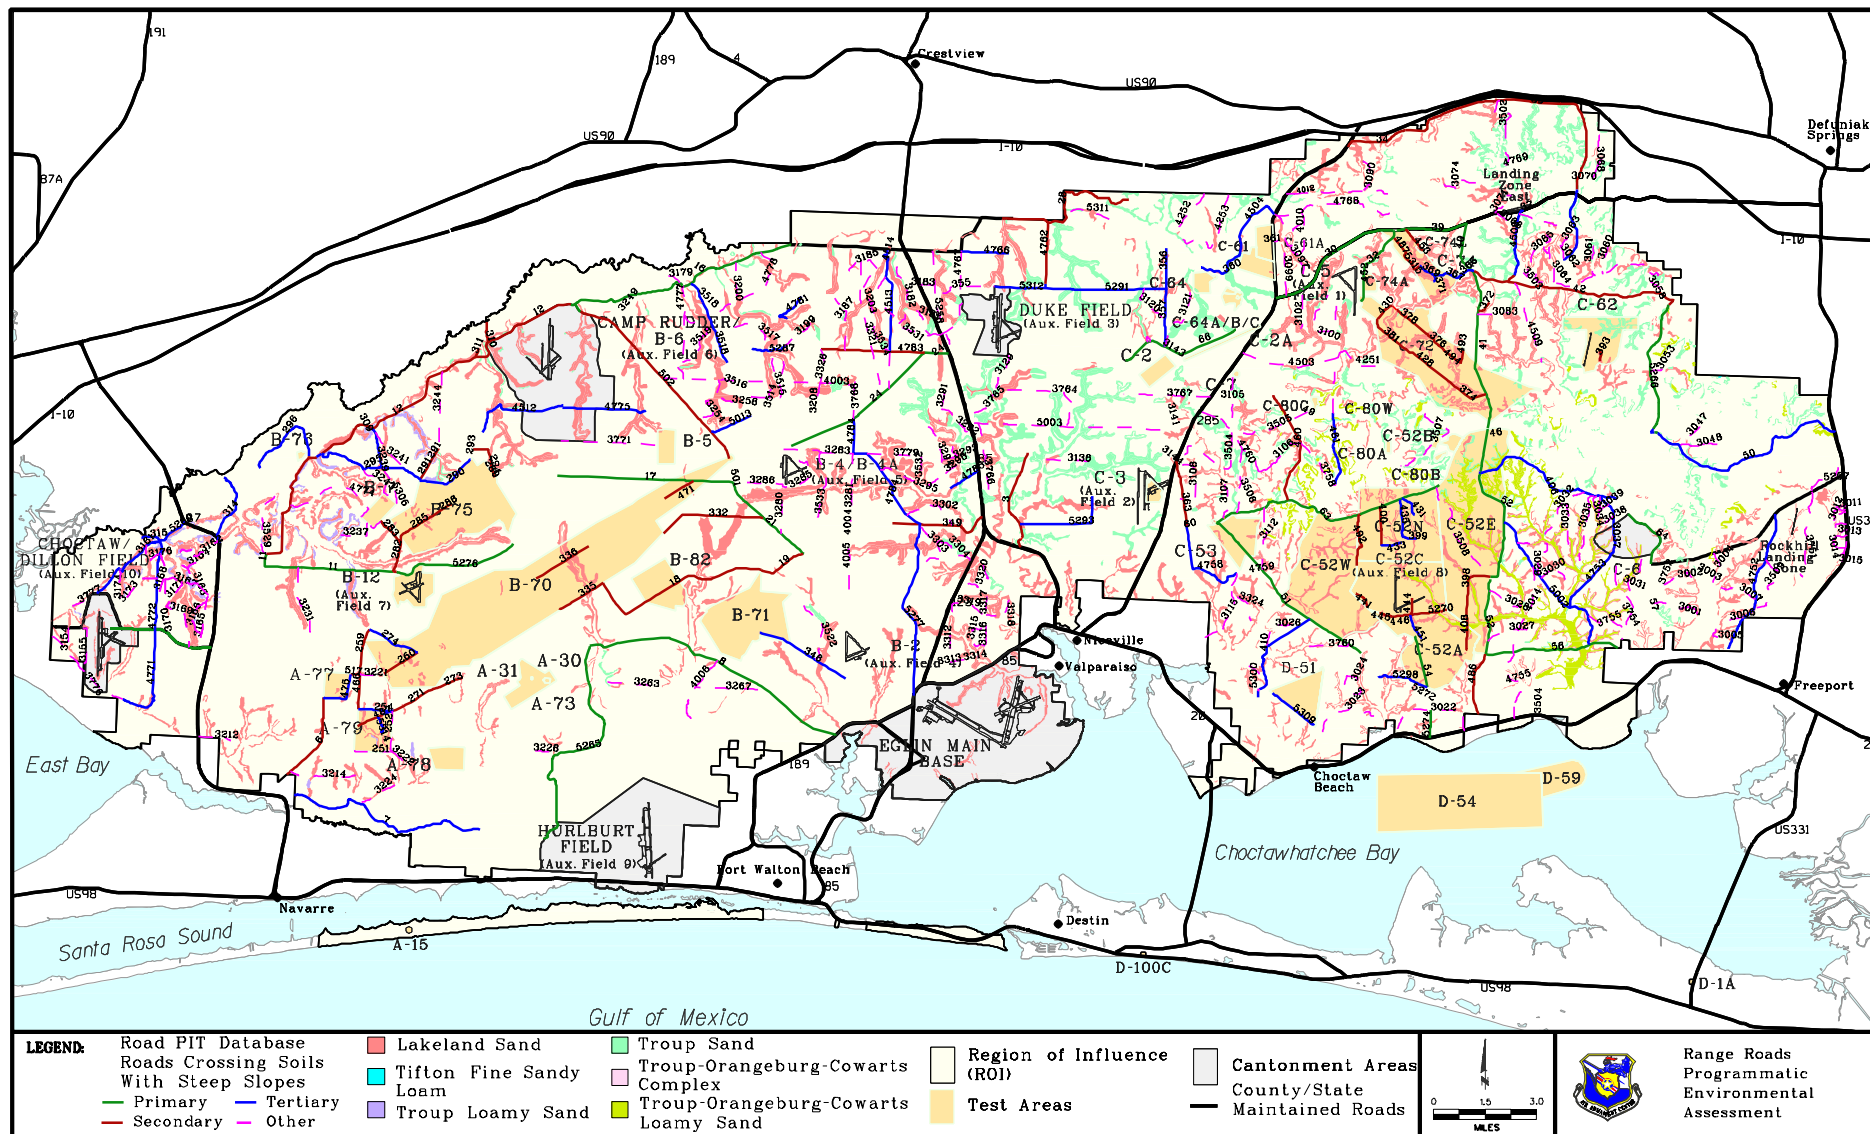
Figure A-3. Road Segments Located on Higher Sloped (> 5 Percent) Soils

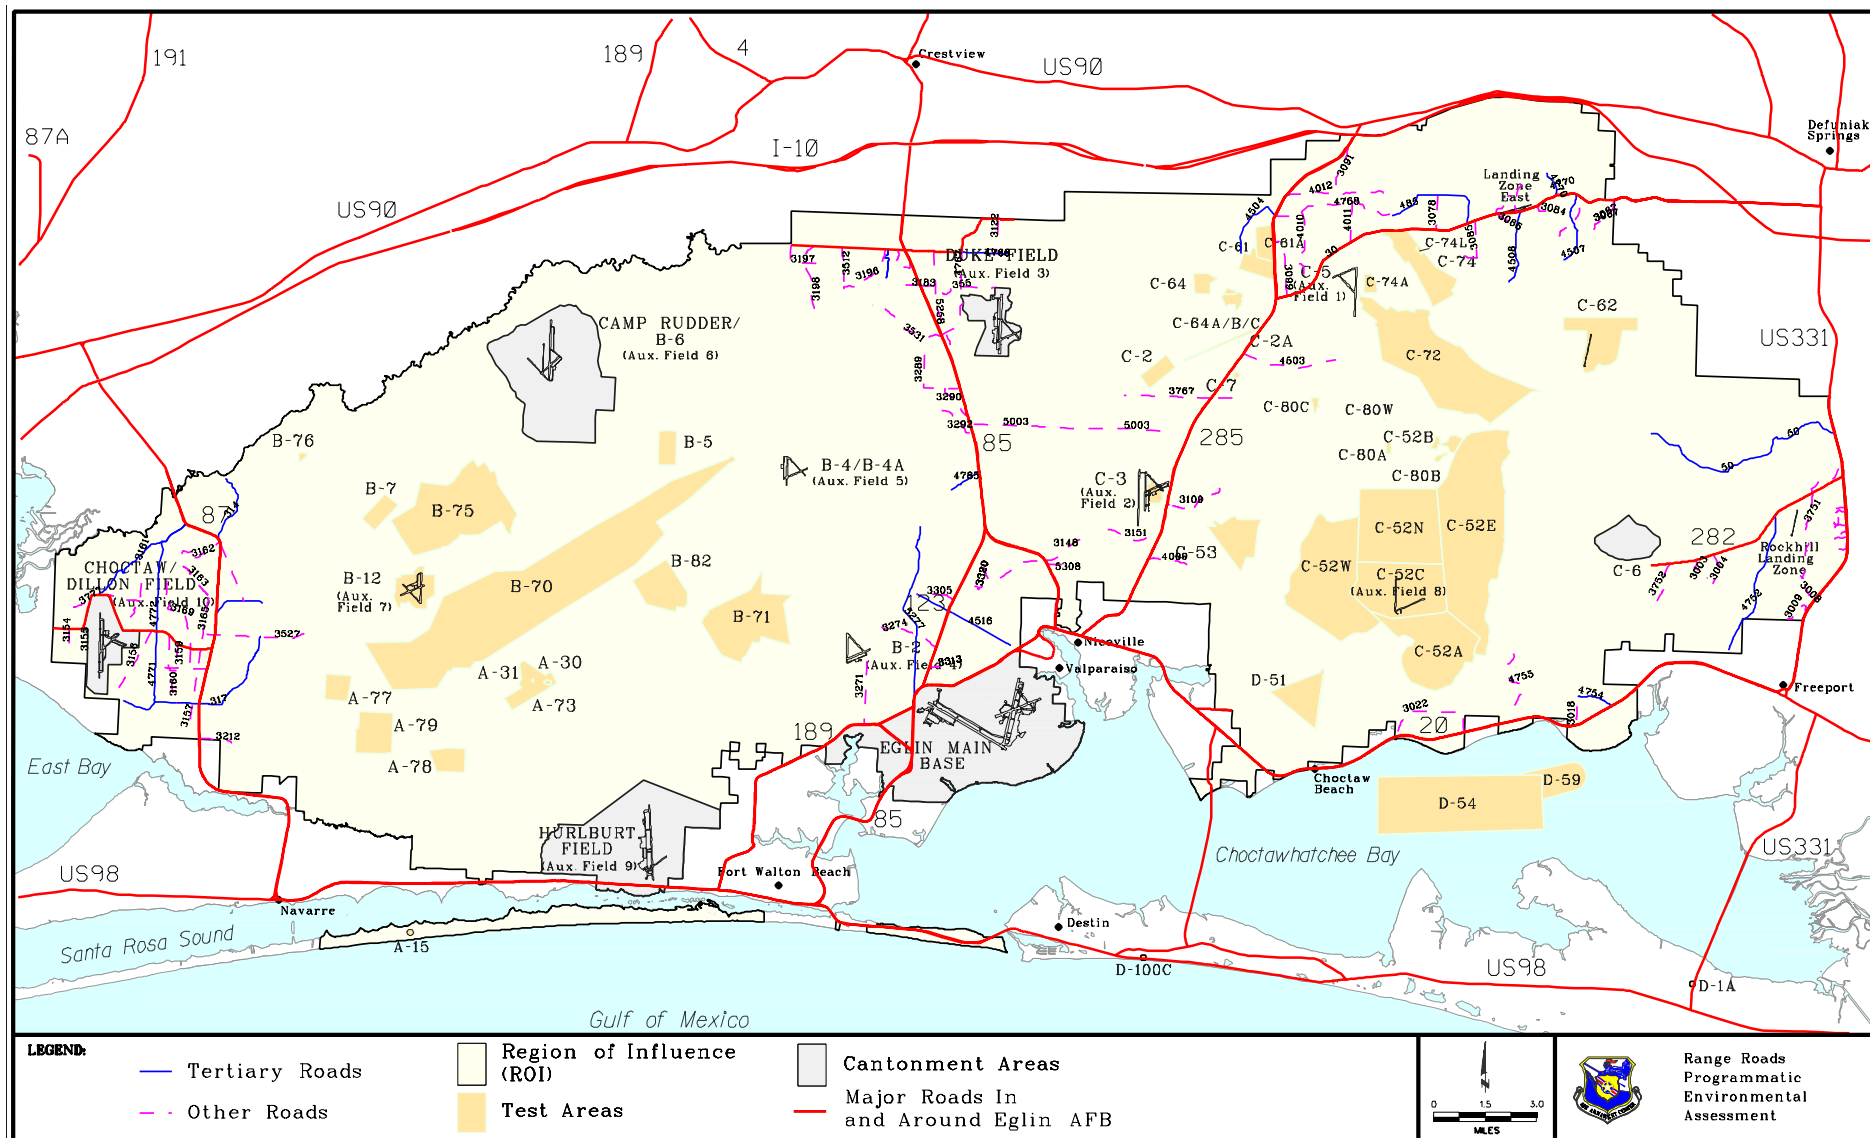
Figure A-7. Access Points (Open and Closed) into the Eglin Reservation from County Roads

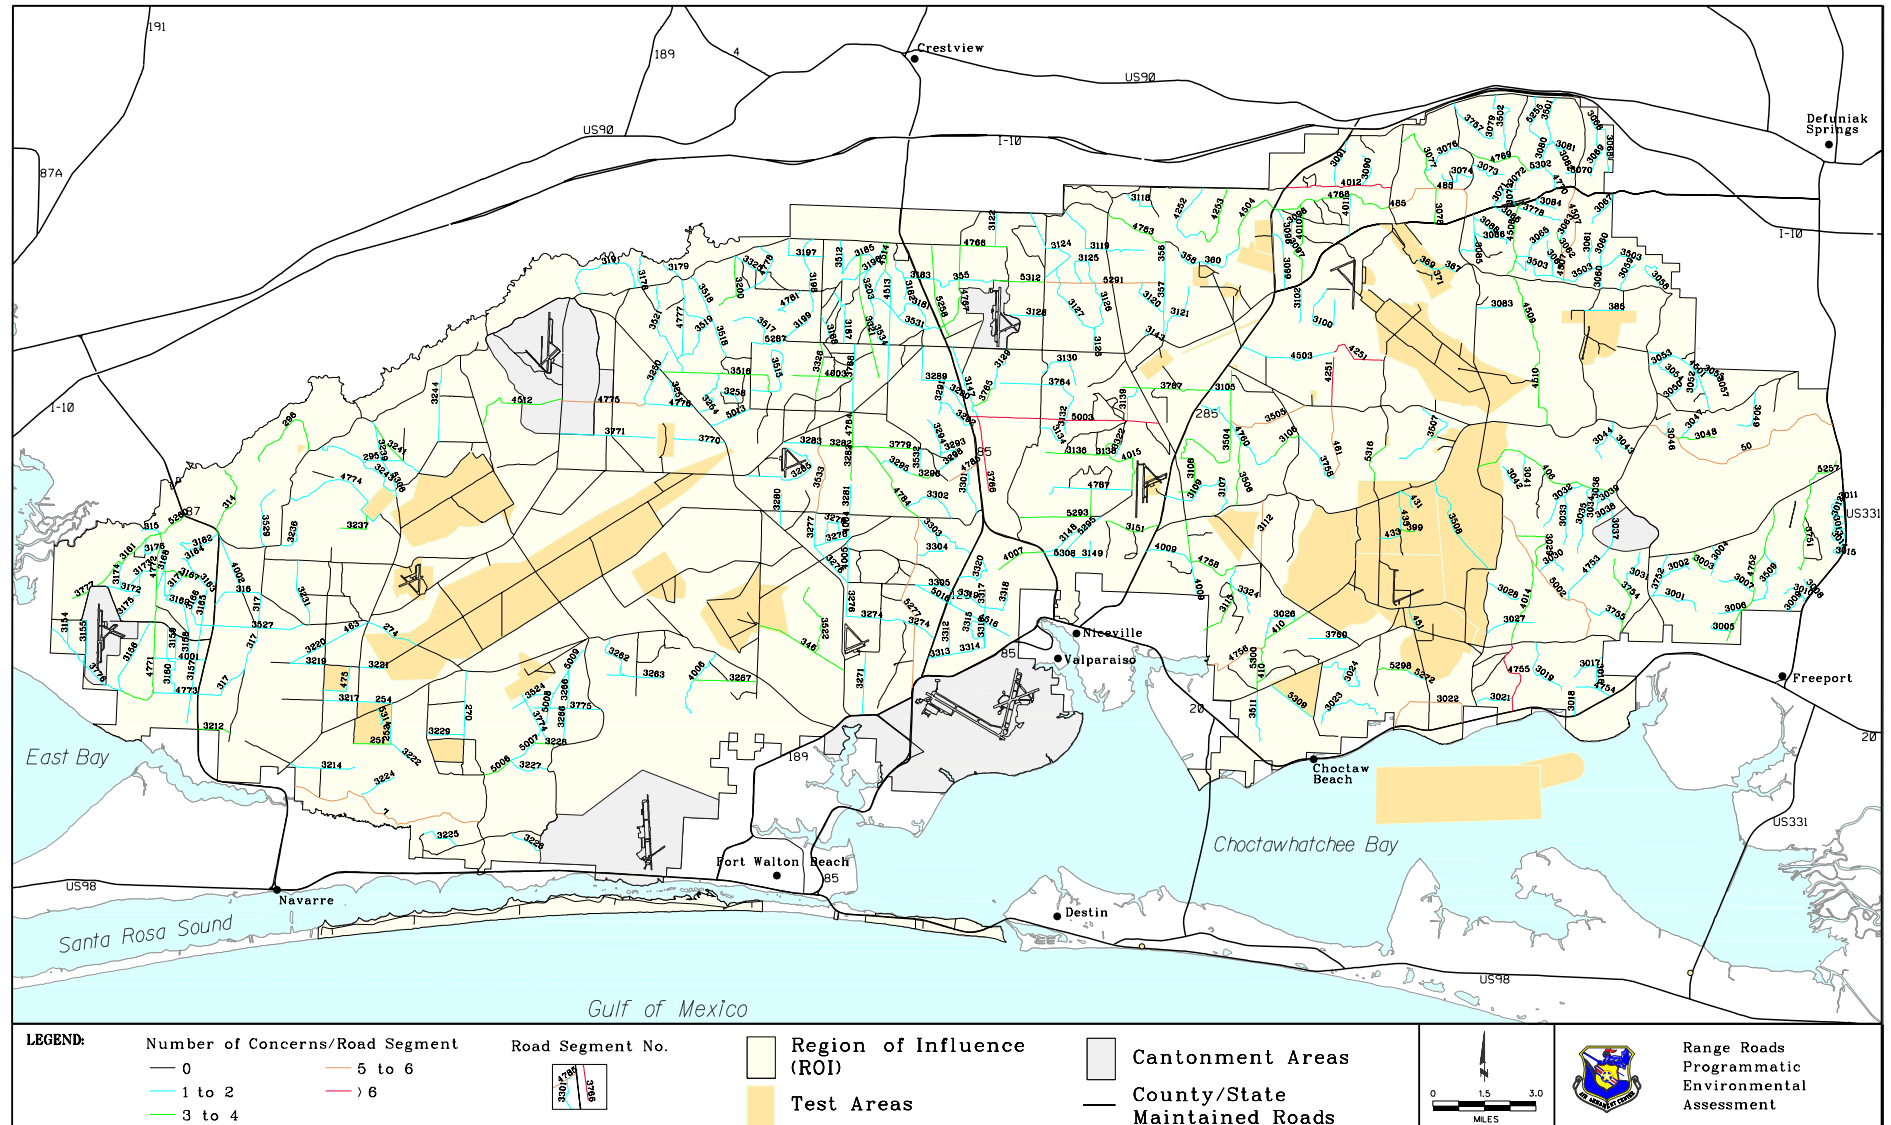
Figure A-8. Example Impact Scoring of Range Road Segments on Eglin AFB

For this assessment, it was assumed that all tertiary or "other" roads with a score higher than "one" would be potential candidates for closure. Further, it was assumed that these roads would be permanently obliterated to minimize environmental impacts. This represents a conservative scenario, since which roads would actually be closed, and at what level of closure, would be determined by the RRWG. For example, closure of some secondary roads could also be accomplished. There are approximately 50 miles of secondary roads, which are classified as having a low to very low priority, and poor to very poor condition. Closure of some of these roads would not only have a positive environmental impact, but would also have a positive financial impact. Maintenance funds are expended on these roads, unlike tertiary or "other" roads, which receive no routine maintenance. Funds saved by closure of these roads could be used to upgrade and maintain remaining secondary roads (AAC/EMH, 2000).
